VICTORIAN CIVIL AND ADMINISTRATIVE TRIBUNAL

VCAT REFERENCE NO. BP1470/2016

Domestic building: failure of timber floor and other minor defects alleged; allegation of edge bonding; owners had engaged builder and floorers separately; owners' case against builder in respect of floor fails: owners case against floorers in respect of floor fails; owners succeeds on minor claims regarding vents and squeaking floor.

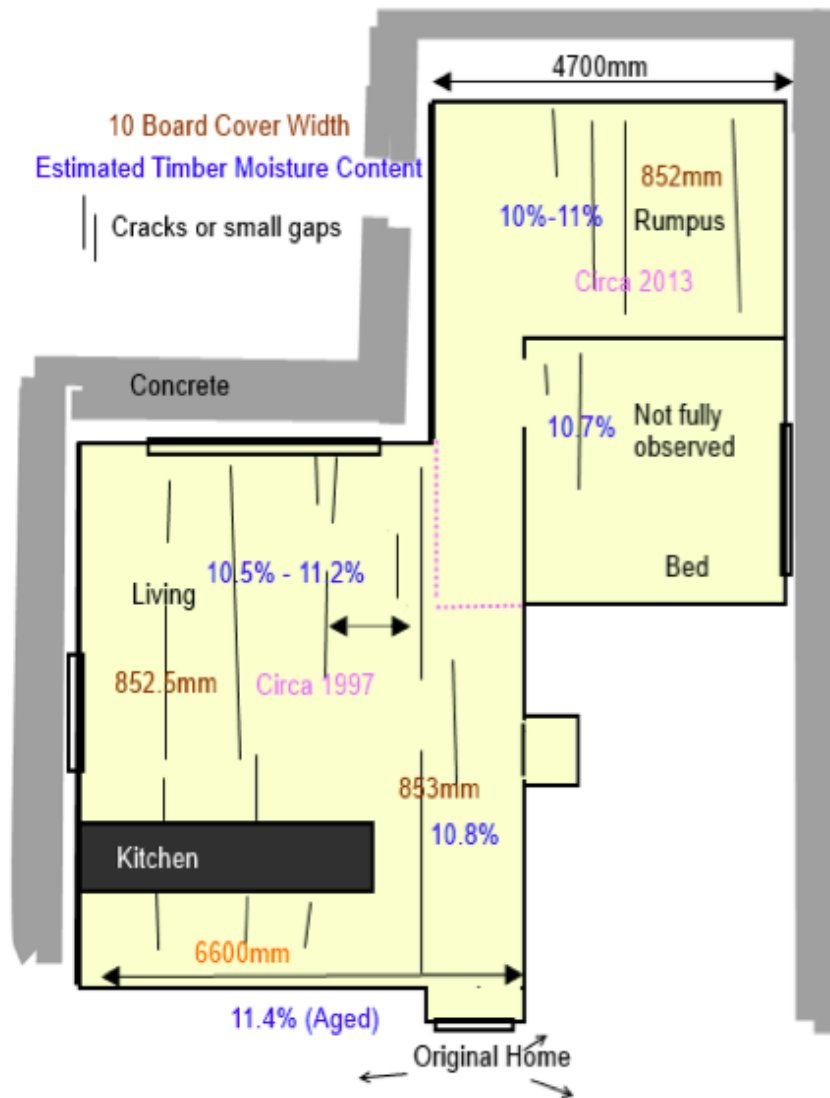
[22] Approximately 30 floorboards have split and cracked (TB 205), such splitting and cracking occurring randomly every 400mm-1000mm / every 5-11 boards (TB 229), observed throughout the entire house including the rumpus room, dining room, kitchen and bedrooms. (TB 156, 187, 242[10], 229.). A diagram of the observable splits and cracks can be seen at part 4.0 of the ATFA Inspection Report (TB 201).

- 13 The layout of the floor, showing where the cracking has occurred is set out in a sketch contained in the Australian Timber Flooring Association ("ATFA") report prepared by Mr Scarpella. It is reproduced below.

- 14 After the site inspection Mr Hay used Mr Scarpella's sketch to mark the location of further cracks that he had identified. The marked up sketch was tendered. Mr Hay counted 46 splits, which is more than he had identified at an earlier inspection, and more than the 32 counted by Mr Scarpella. This suggests the process of board splitting is continuing.
- 15 As the extent of cracking is not in issue, it is not necessary to refer to the observations concerning the cracking made by Mr Salvatore Mammone in his Inspect Direct report dated 29 January 2015, or by Mr Bruce Grahame in his Victorian Building Authority report dated 24 March 2017. Both reports were tendered, even though neither Mr Mammone or Mr Graham were called.
- 16 The owners go on to describe the failure of the floor in their opening submissions in these terms:

[23] The crack lines propagate along the length of the top shoulder of the groove side of floorboards (TB 242[10], 243[13], 216). The crack lines in each room run approximately the total width of the room in an east west direction. Cracks are greater than 2mm in width for more than 1m in length in many places (TB 187).

[24] Splitting has also been observed along the bottom section of the groove profile. This has resulted in the total separation of connections between boards. This means there is no support within the span between joists and therefore deflection can occur with loss of structural integrity (TB 268).
