eath 8 hoto Wa taken just months collapse reveals major flaws before The

# 4 NEWS THURSDAY, APRIL 4, 2013 HERALDSUN.COM.

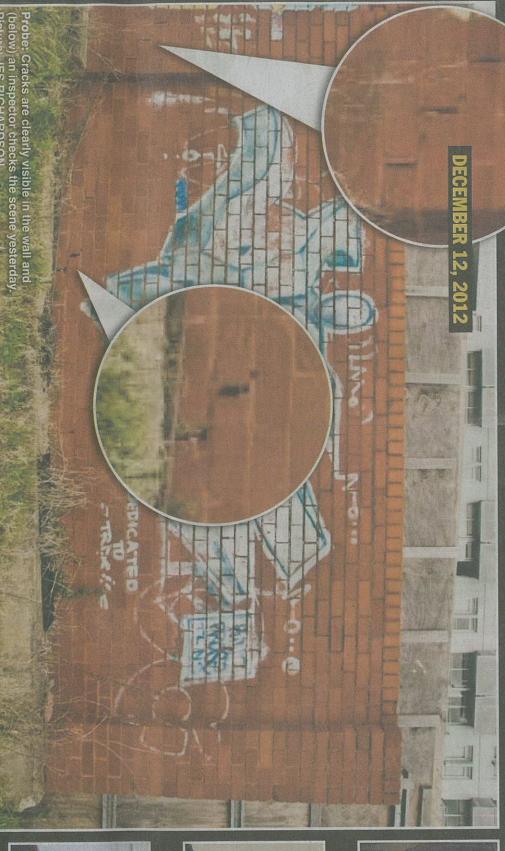
lapsed killing three people was riddled with cracks, photographs taken just four months before the tragedy reveal. Photographs obtained by the Herald Sun are now expected to form a crucial part of investigations into last week's tragedy.

Engineering experts have said the "significant" cracking would have made the wall unable to resist Thursday's

strong winds. The photographs, taken on December 12 last year, are the only images in the public domain that show the condition of the wall before its collapse.

Dr Con Adam, senior research fellow in the school of civil engineering at Monash University, said the cracks caused the wall's collapse.

"That picture tells us a lot about the wall. The wall as a whole was under sheer failure, this renders the wall unable to resist wind loads," he said.

"If there is a crack in the bottom of the wall it just couldn't resist the wind load. That crack at the base of the wall was the weakest point."

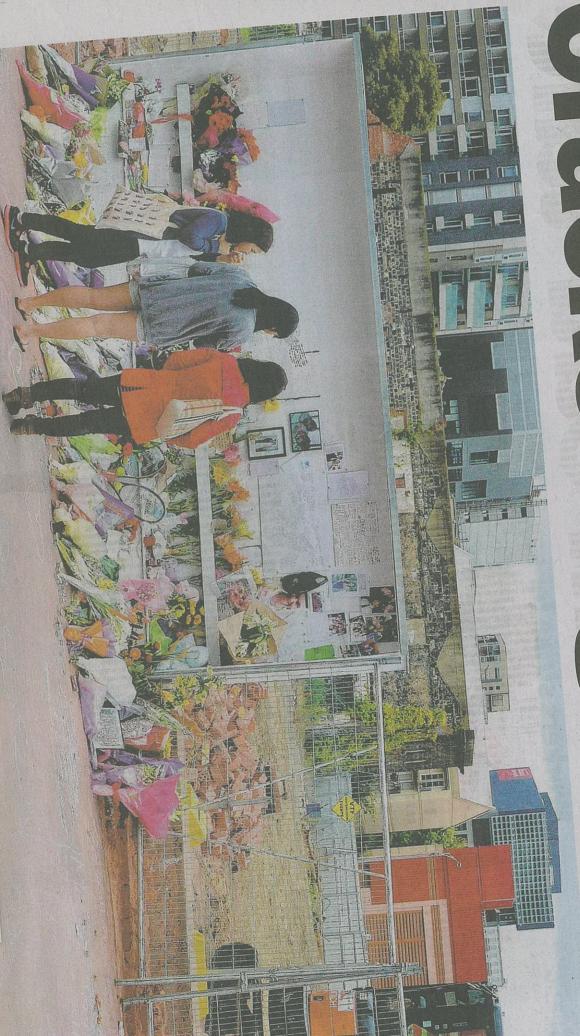
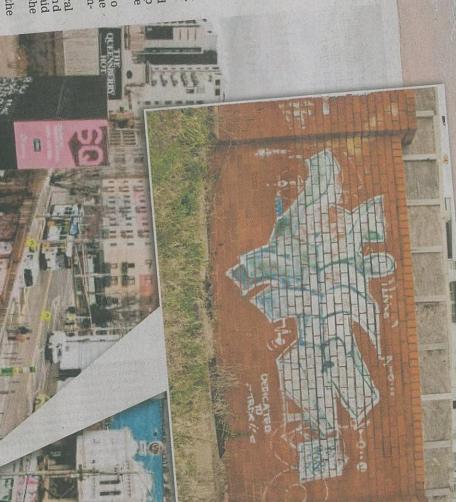
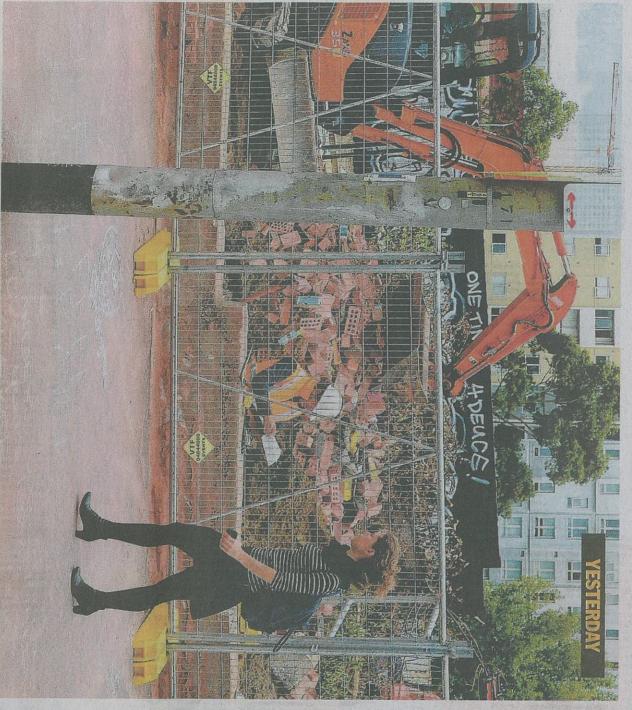
**Triple tragedy:** (clockwise from above) The scene of the Swanston St wall collapse yesterday; inspectors investigate the site; photographs of the wall, taken four months ago, reveal cracks in the lower bricks and show that the hoarding is higher than the wall. Pictures: TIM CARRAFA,

# The school memorial comes as investigations into the triple fatality began at the site yesterday. Grocon in spectors scoured the former Carlton United Brewery site, taking photos, collecting soil and rock samples, and measuring remaining foundations of the wall. An excavator was also used to dig a Im-deep hole adjacent to the wall, directly where it weakened and fell. WorkSafe, the State Coroner, Victoria Police and Grocon, which owns the site, are all conducting separate investigations. Anthorities are remaining tight-lipped about their inquiries and whether anyone had done anything wrong. Roberto Cimino, who has been in the architecture and construction industry for 20 years, visited the site yesterday in an attempt to reach his own conclusions about what happened. He added that "cutting comprehas been erected as a tribute and is now laden with flowers, candles and other mementoes. Dylan McEune, 19, had been too distraught to visit the site to say goodbye to his mate, Alexander, known to friends as "Zandeer", until yesterday. Tit is so hard to comprehend why this has happened, and that they are gone," Mr McEune said. "Everyone is still in shock and trying to come to terms with this." Friends and former colleagues of Dr Fiawoo, a Monash University research fellow, were just as shocked as news of her death spread around France yesterday. Speaking from Dr Fiawoo's hometown of Paris, down on top of them last Thursday. Talented French researcher Marie-Faith Fiawoo, 33, was also killed in the tragedy. THE Montmorency community will gather today to remember the Jones siblings — a week after a freak wall collapse claimed their lives. Montmorency Secondary College will open its doors to students, friends and family of former students Alexander and Bridget Jones between 11am and 3pm. Alex, 19, and Bridget, 18, were walking along Swanston St in Carlton when a brick wall came crashing down on top of them last Thursday. A significant crack in the wall would have caused it to collapse under strong winds Westerly gusts of 102km/h were recorded at St Kilda, the nearest accurate wind station, at 2.59pm last Thursday The mortar used at the time the wall was thought to have been built was lime-based, which loses strength over time Steel columns, or straps, could have cheaply strengthened the wall WorkSafe inspected workers putting up a wooden hoarding on the site on October 12, 2011 The wooden hoarding was 300-400mm higher than the brick wall MONY MO
